CASE STUDY

Product	Suction and Discharge Valves
Segment	Chemical Industry
Case n°	2016.005

A high pressure reciprocating pump, operating with ammonia (NH_3) at a fertilizer production plant, presented frequent suction and discharge valve failures.

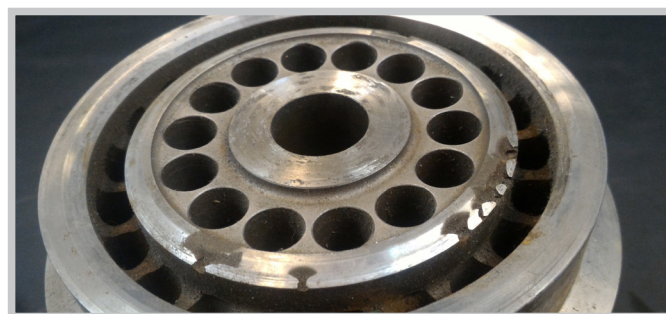
| Reciprocating Pump

The failures were caused by the ammonium carbonate corrosive action, an intermediate product of the urea synthesis. Besides limiting valve life span to approximately 7 months, the corrosion, mainly of the sealing areas, made valve reconditioning impossible.

Manufacturer	Uracá
Model	KD815
Fluid	Ammonia
Rotation	169 rpm
Final Pressure	200 bar

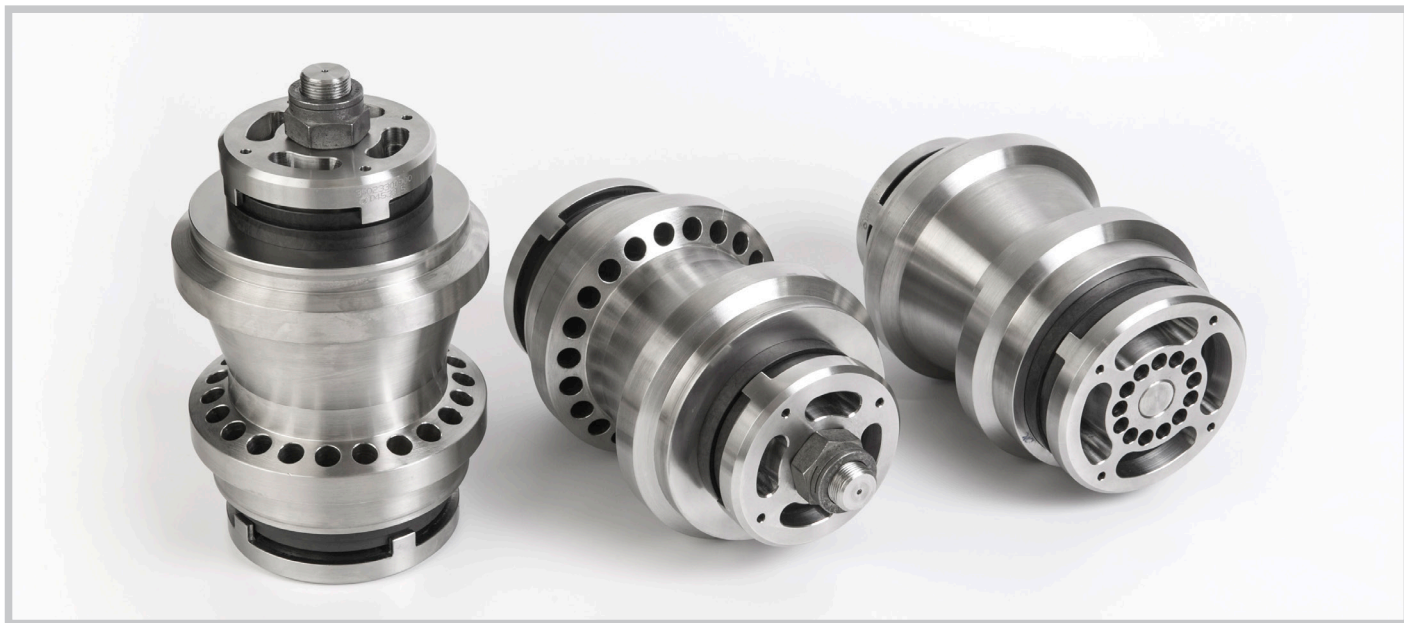
| Selco Solution

Taking into consideration the reciprocating pump operational conditions, as well as the ammonium carbonate chemical properties, Selco developed a material able to simultaneously resist mechanical wear, and corrosive action.

Besides a valve life span increment, the new project also optimized the ammonia flow, with a subsequent increase in productivity.

The new project led to an approximate increment of 250% in valve life span, going from 7 to 24 months. Besides, the reduction in maintenance stops increased the reciprocating pump operational availability to 18,000 hours.

Valve reconditioning became viable with the elimination of the corrosive effect, while enabling the client to merely exchange the sealing elements. The reconditioned valve costs less than 20% of a new valve, generating significant savings for the client.
