CASE STUDY

Product	Actuators
Segment	Chemical Industry
Case n°	2017.002

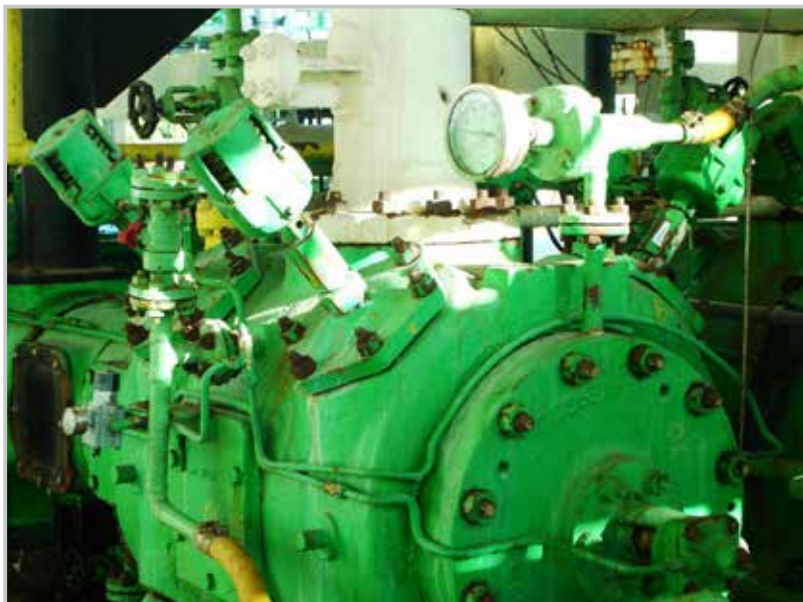
| Original Project

A reciprocating compressor at a propene processing production plant was presenting constant reverse type actuator problems. The sealing features of the original actuator were not efficient, and because of that the valves operated partially open. This frequent failure compromised the compressor performance. Also, the reconditioning of the original actuator was time consuming due to its complex design. Finally, the plant was subject to sea air, which caused corrosion in the actuator because its parts were mostly made of carbon steel.

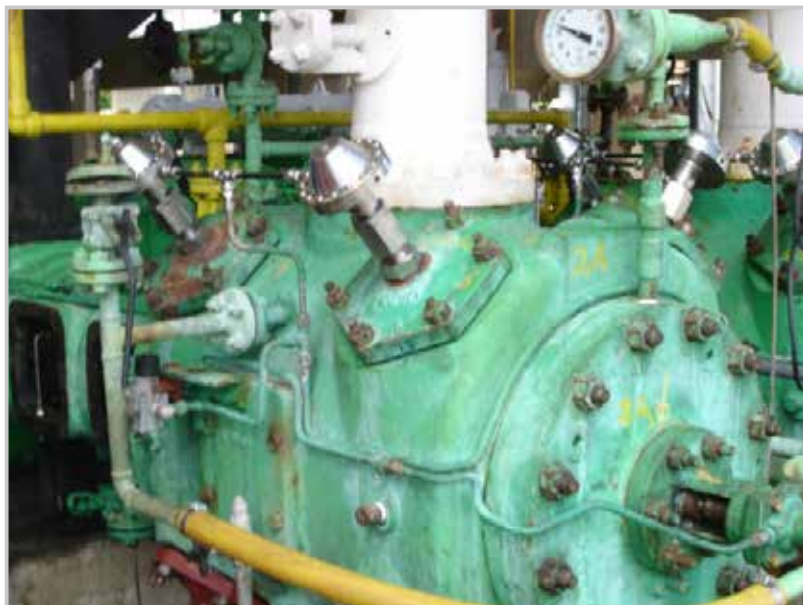
| Selco Project

Selco selected its exclusive actuator **Sc-Force** to solve the issue. This modern design actuator presents a robust and efficient sealing system. This enables precise valve activation, allowing the compressor to reach its full operational capacity.

The simplified construction of the actuator enables ease of reconditioning, and the selected quality materials provide for prevention of corrosion build up, as well as promote increased operational life.

The original project presented failures within a single production year, while **Sc-Force** actuator has been operating free of problems for over a decade. The simplified construction of the actuator will allow for a swift reconditioning when needed.
